2018 Investigation of Twelve Sandwich Ponds

BY WATER RESOURCE SERVICES, INC.

MARCH 2019

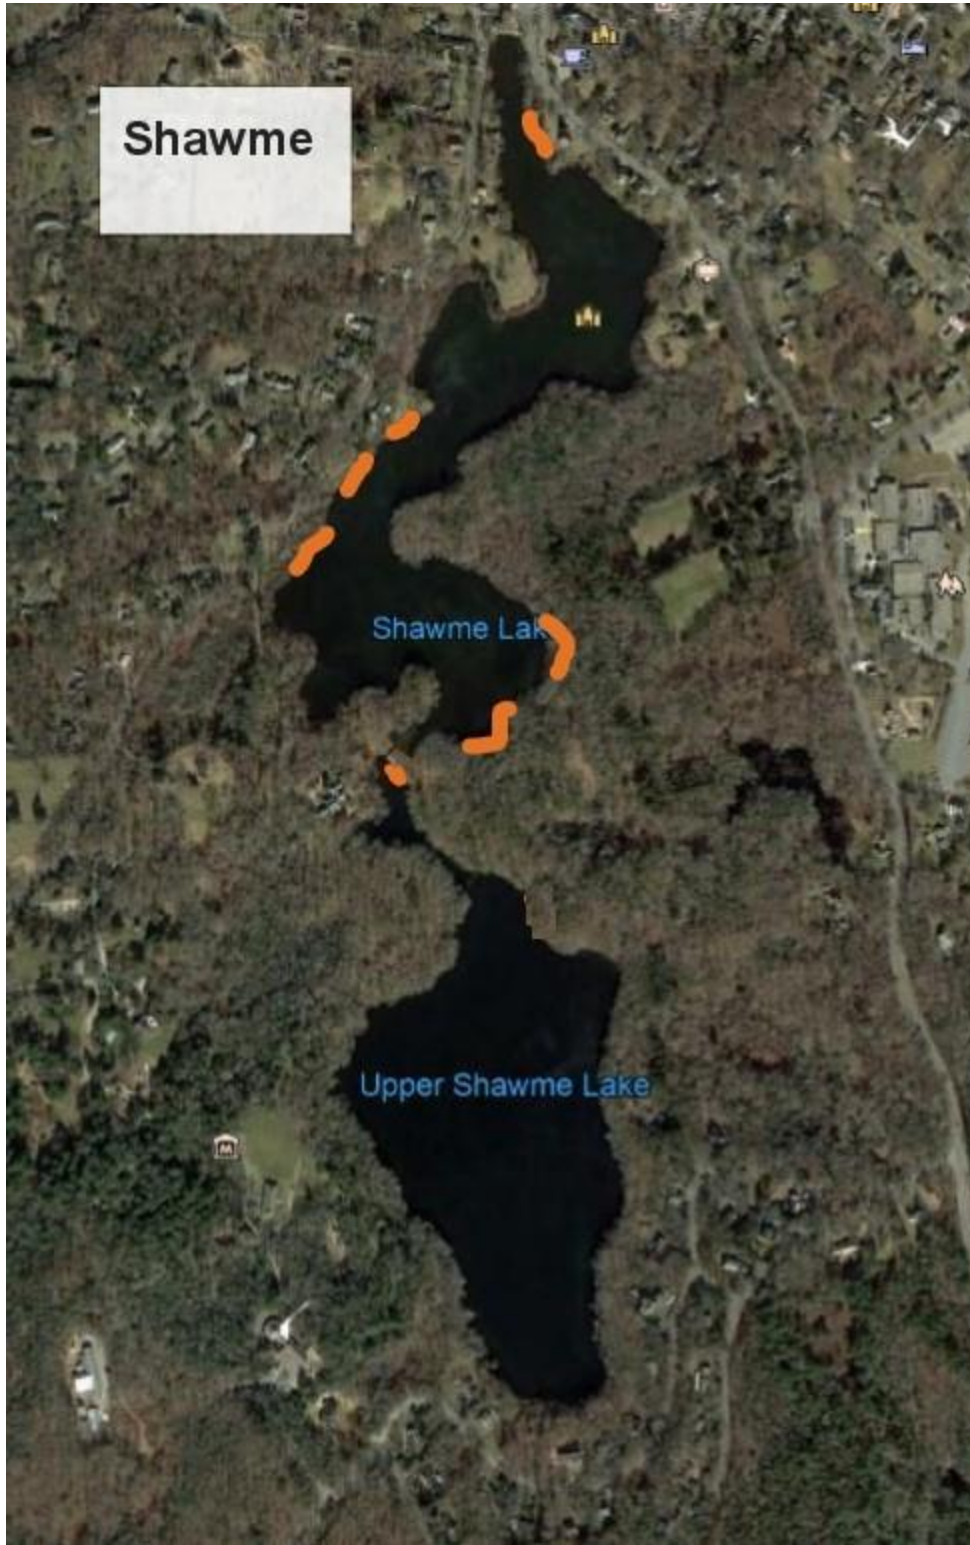
Figure 8. Phragmites patches at Upper and Lower Shawme Ponds

Common reed (*Phragmites australis*) and purple loosestrife (*Lythrum salicaria*) were found in 2018 at six peripheral locations (Figure 8) with *Phragmites* dominant and scattered plants of *Lythrum* on the margin of the patch. Patches ranged in size from about 50 to 150 feet in length but were generally thin at 10 to 15 feet of thickness at the shoreline. The patch closest to the outlet is accessible from land, but the others are largely inaccessible except by boat due to thick shrubby vegetation on the landward side. An additional very small *Phragmites* patch was found on the Upper Shawme Pond side of the berm that represents the boundary between the Upper and Lower Shawme Ponds. That small patch is easily accessible from land.

One issue for Lower Shawme Pond worth addressing quickly is the relatively early infestation with common reed and purple loosestrife, two invasive species that should be controlled soon to avoid a much bigger problem later. There are multiple means for controlling *Phragmites* and *Lythrum*, and both physical and chemical controls could be viable in these ponds. Killing the entire plant is the goal, and herbicides provide the greatest probability of success in the shortest time. However, it is rare to get more than a 90% kill rate in the first year of application, as getting even application in a *Phragmites* and/or *Lythrum* patch is challenging and getting complete distribution of herbicide to all plant roots is not guaranteed. A three-year program is therefore advised, with sequential treatment as needed in years 2 and 3. At that point, *Phragmites* and *Lythrum* should be eliminated or reduced to such low densities that hand pulling is feasible as a follow up as warranted.

Failure to address the *Phragmites* and *Lythrum* at this early stage of invasion is likely to result in a peripheral monoculture of *Phragmites* over a period of years, with attendant loss of habitat value and aesthetic appeal. Some areas of Cape Cod have been overrun by *Phragmites* and control becomes more difficult in terms of effectiveness, cost and regulatory constraints when the infestation is expansive. Note that three other ponds in Sandwich have small stands of *Phragmites* and/or *Lythrum* (Peters, Pimlico and Weeks Ponds) and a program that addresses all of them would be appropriate and may produce cost savings. The overall cost of a complete program for all Sandwich ponds with these invasive shoreline plants has been estimated at about \$50,000 over three years for control with herbicides and at least \$100,000 for control by physical means.

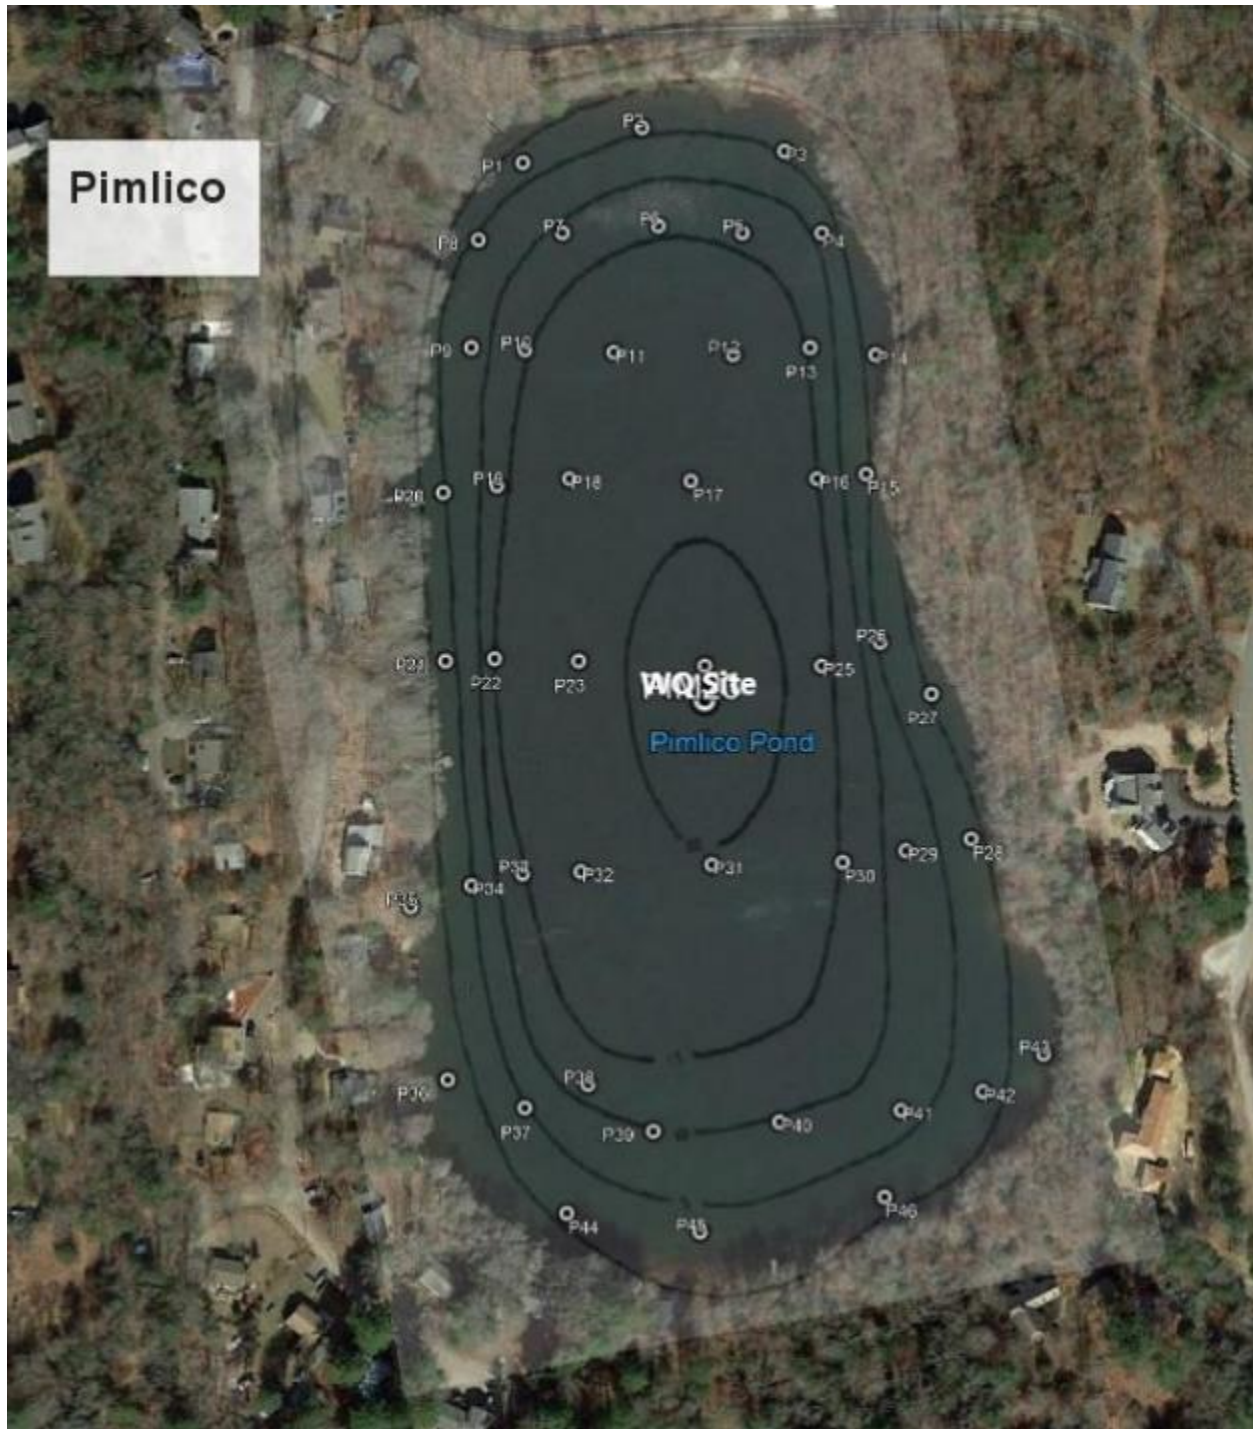
Figure 34. Pimlico Pond survey points.

Pimlico Pond was sampled in August 2018 as part of this investigation at its deepest point and surveyed at 46 additional locations (Figure 34). Unlike the 2003 review, WRS found oxygen depletion near the bottom under about 23 feet of water and slight oxygen depression in 20 feet of water, above which the

Phytoplankton sampling occurred at the water quality assessment site (Figure 34) and revealed an elevated biomass but no cyanobacteria (Table 11). The diatom *Urosolenia* was dominant, which is unusual

Zooplankton sampling was conducted at the water quality assessment site (Figure 34) in August 201 and revealed a moderate biomass with a desirable mean body length for crustacean zooplankton (Table 11). The sample was dominated by quick swimming calanoid copepods and small bodied cladocerans, indicative of substantial predation by small fish. Grazing capacity would be considered moderate.

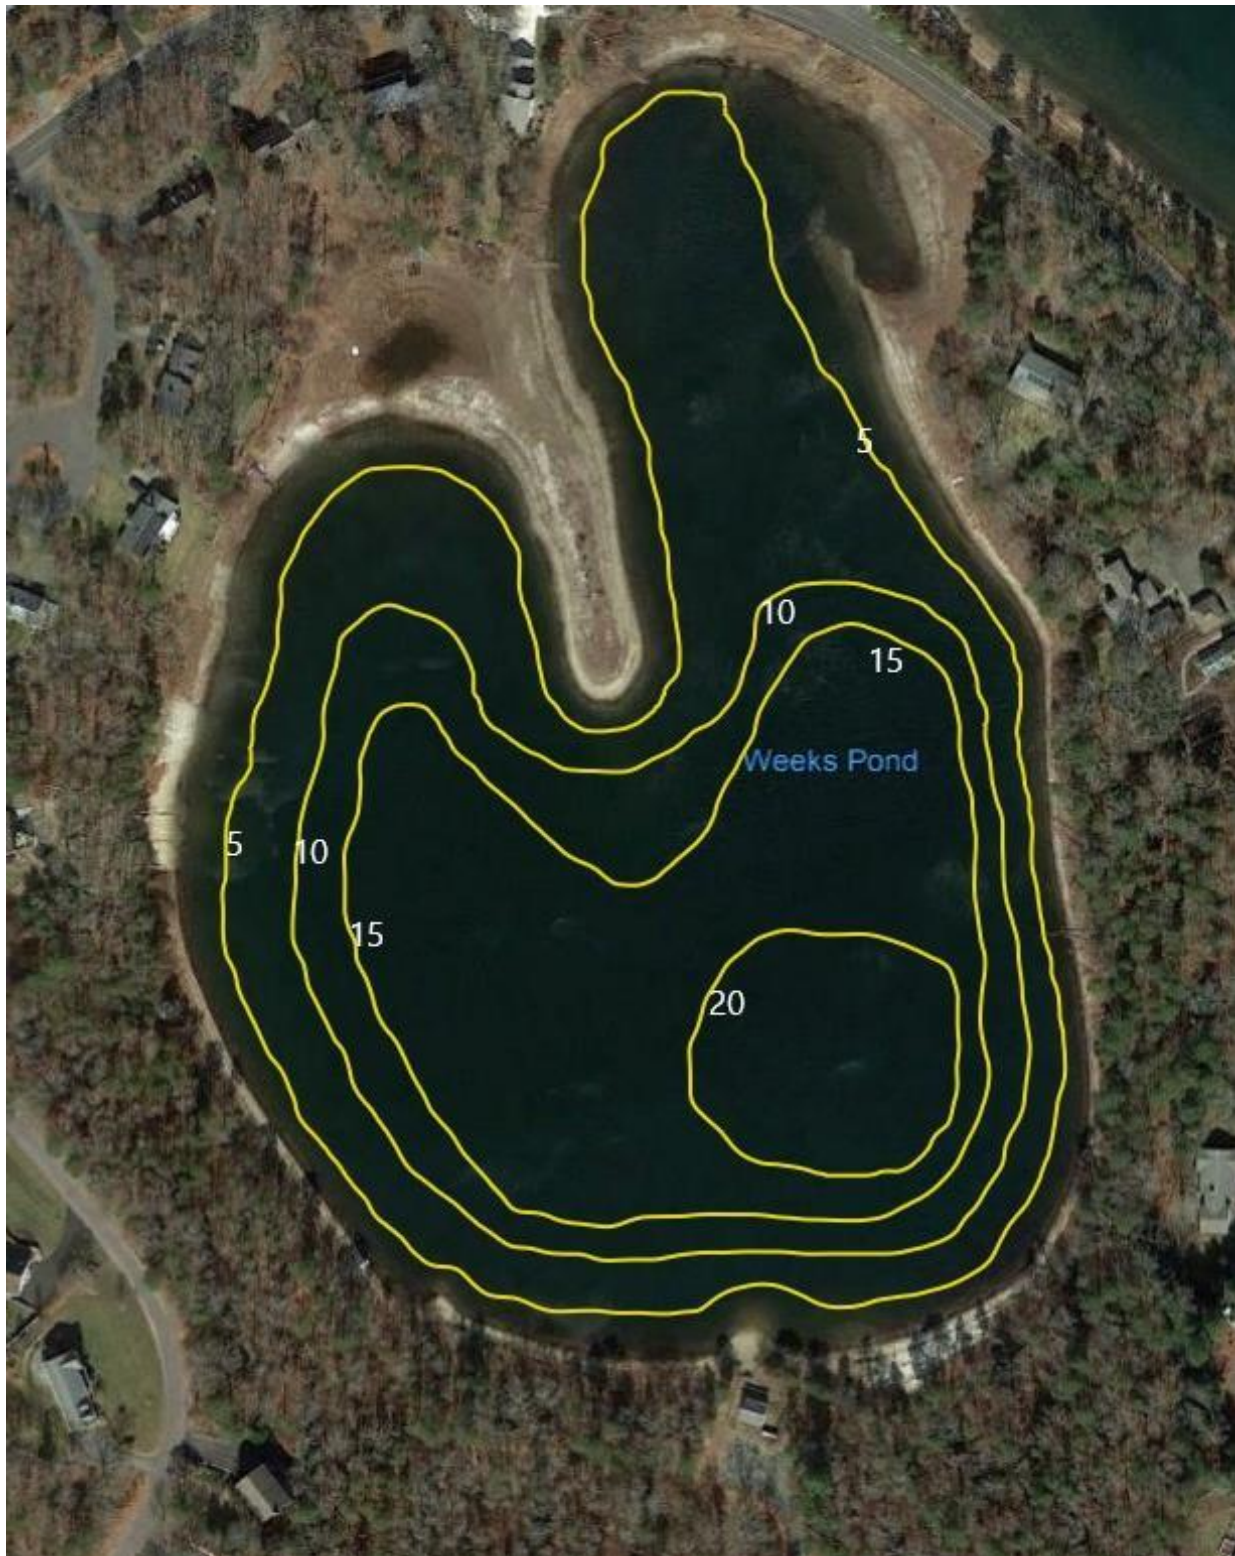
Figure 41. Bathymetry of Weeks Pond from WRS 2018 measurements.

under water in August 2018. The water level as shown in Figure 41 may be lower than average, but the peninsula supports terrestrial vegetation and is therefore not usually under water.

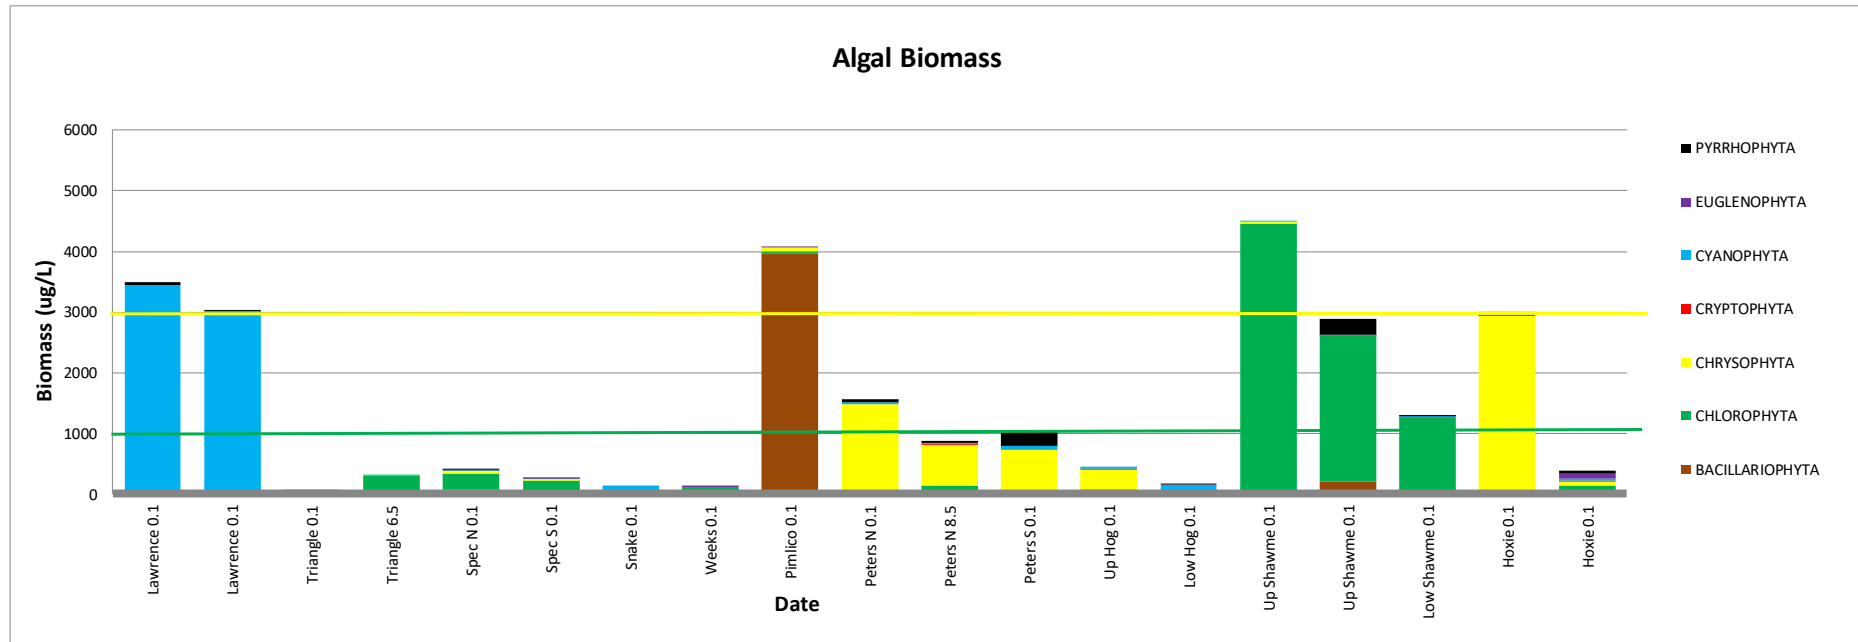
Green line represents the biomass below which no algae-related problems are expected.
